## The Challenge of Corrosion in Orthopaedic Implants

Kenneth L. Urish, MD, PhD; Paul A. Anderson, MD; William M. Mihalko, MD, PhD; and the AAOS Biomedical Engineering Committee

AAOS Now

April 2013 Issue

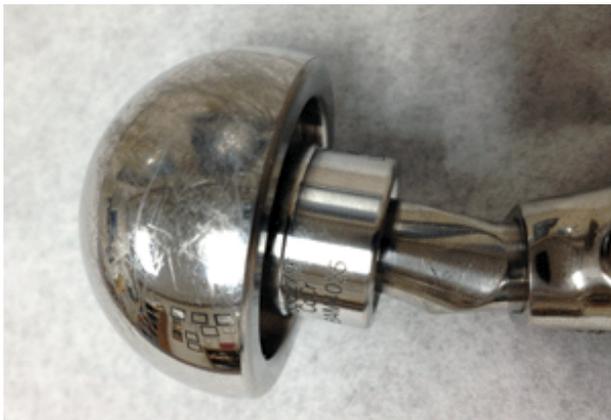
**Fig. 1** Modularity can be the weak point in the implant design and the source of more debris from corrosion.

Fretting corrosion can be increased in a large metal-on-metal head due to the greater surface area of the bearing and the increased forces across the taper junction. When modularity is introduced at the neck, adding another taper junction, the debris from fretting corrosion can increase significantly (Fig. 1).

Corrosion continues to be a problem in orthopaedic implant despite more than four decades of experience. The passivation layer prevented initial fears of galvanic corrosion between certain pairs of mixed metals from occurring, but fretting corrosion is a major contributor to debris in many newer designs. When the correct criteria are met, crevice corrosion and fretting can lead to early implant failure. All surgeons should be cautious when adding levels of modularity that can add more debris to an implant system.
