Trunnion Corrosion

Dual Taper Corrosion

Catastrophic Trunnion Failure

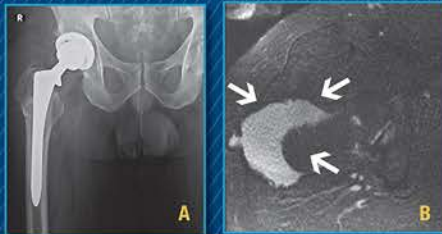
A: Radiographs of revision THA for MoM ALTR. MoM bearing was replaced with metal on polyethylene bearing.

B: MARS MRI demonstrated a thick walled cyst with a large fluid collection (arrows).

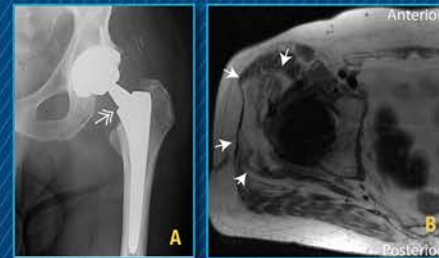
A: Radiographs demonstrated a neck-stem "dual modular" taper (double arrow) with no bone loss or medial calcar erosions.

B: MARS MRI demonstrated a complex heterogeneous mass (arrows).

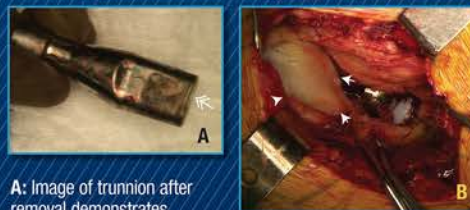
A: Image of trunnion after removal demonstrates corrosion on the taper interface (double arrow).

B: ALTR (pseudotumor) was observed around the capsule (arrows).
